Manhole Inspection Summary

Manhole # S55K__058MH

Insp Date: **5/29/08 1:14 PM**

Location Address: **8q13 s conkling**

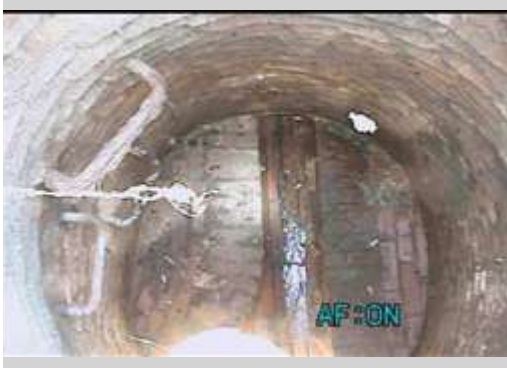
Defect 1

Steps Count: **3** Missing: **0** ☒ **Corroded**

steps

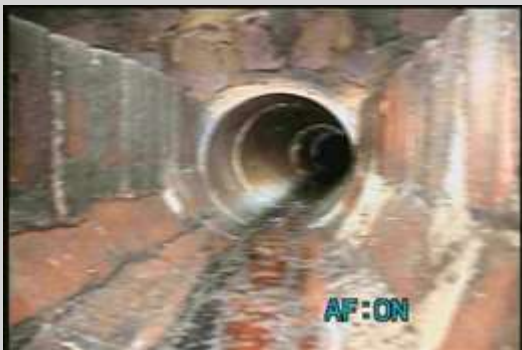
12 O'Clock Outflow

8 in. Circular Gravity Sewer
Pipe Out @ 12 O'Clock

Invert Depth: 7.80 (ft.) Flow Characteristics: Slow

Infiltration: None Pipe Seal Cond: Unknown

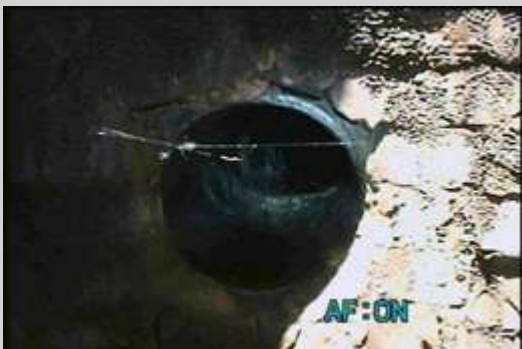
6 O'Clock Inflow

8 in. Circular Gravity Sewer
Pipe In @ 6 O'Clock

Invert Depth: 7.10 (ft.) Flow Characteristics: Slow

Infiltration: None Pipe Seal Cond: Unknown

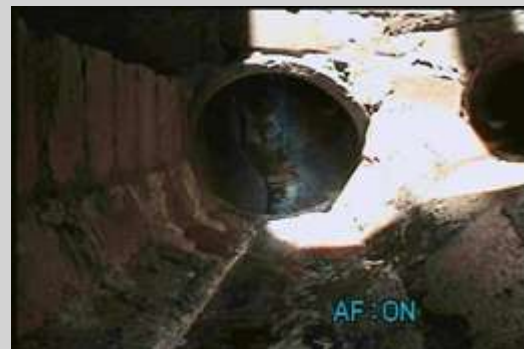
Drop In @ 6 O'Clock

Drop: Outside Direct

Inv Depth: 7.70 (ft.)

Drop Condition: Open

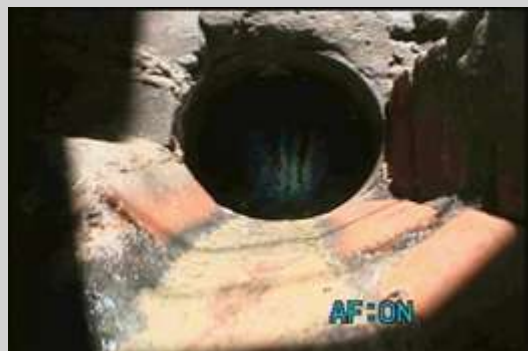
7 O'Clock Inflow

8 in. Circular Gravity Sewer
Pipe In @ 7 O'Clock

Invert Depth: **6.10** (ft.) Flow Characteristics: **Slow**

Infiltration: **None**

Connects To: **House connection / Service line**
